Manhole Inspection Summary

Manhole # **S39CC_035MH**

Insp Date: **3/5/08 1:26 PM**

Location Address: **1000 EAGER ST**

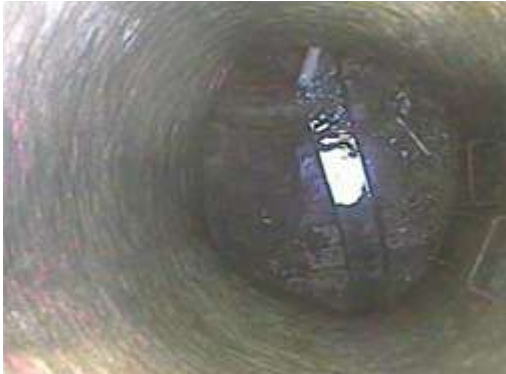
Defect 2

Count: **6** Missing: **3** ☒ **Corroded**

STEPS CORRODED

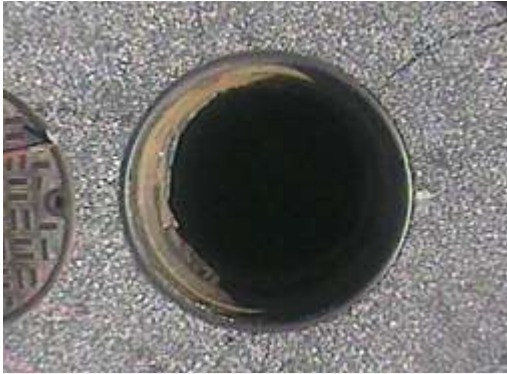
Defect 1

Offset: **1** (in.)

FRAME OFFSET

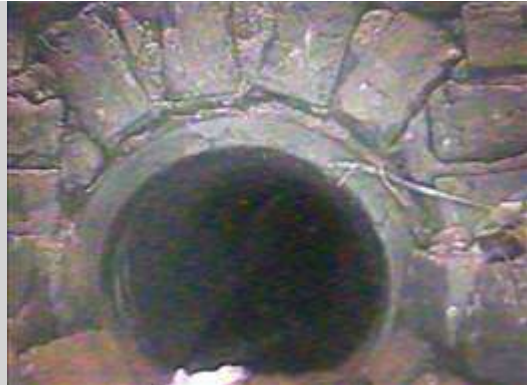
12 O'Clock Outflow

8 in. Circular Gravity Sewer
Pipe Out @ 12 O'Clock

Pipe Height: (in.) Direct
Pipe Material: **Clay** ☐ Pipe Lined
Invert Depth: **10.95** (ft.) Flow Characteristics: **Slow**
Deposits: ☒ None ☐ Mud ☐ Sludge ☐ Debris ☐ Grease
Silt Depth: (in.) Deposits Extent:
Infiltration: **None** Pipe Seal Cond: **Sound**

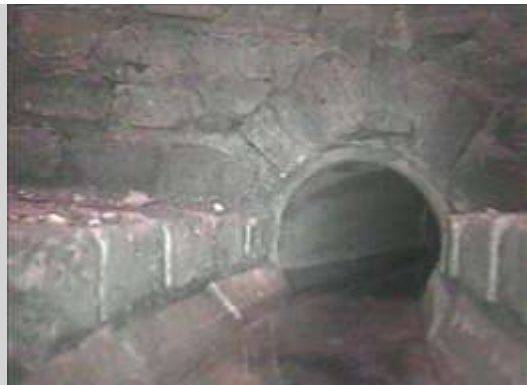
5 O'Clock Inflow

8 in. Circular Gravity Sewer
Pipe In @ 5 O'Clock

Pipe Height: (in.) Direct
Pipe Material: **Clay** ☐ Pipe Lined
Invert Depth: **10.91** (ft.) Flow Characteristics: **Slow**
Deposits: ☒ None ☐ Mud ☐ Sludge ☐ Debris ☐ Grease
Silt Depth: (in.) Deposits Extent:
Infiltration: **None** Pipe Seal Cond: **Sound**

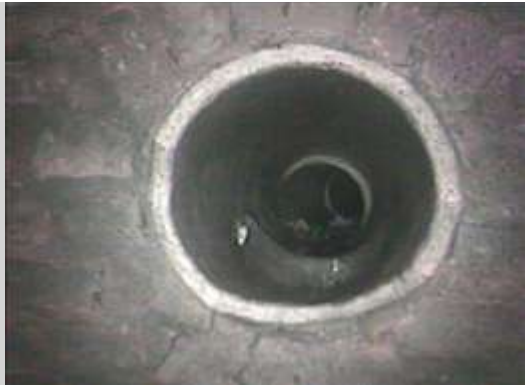
9 O'Clock Inflow

Pipe In @ 9 O'Clock

Invert Depth: **9.13** (ft.) Flow Characteristics: **Fast**

Infiltration: **None** Pipe Seal Cond: **Sound**

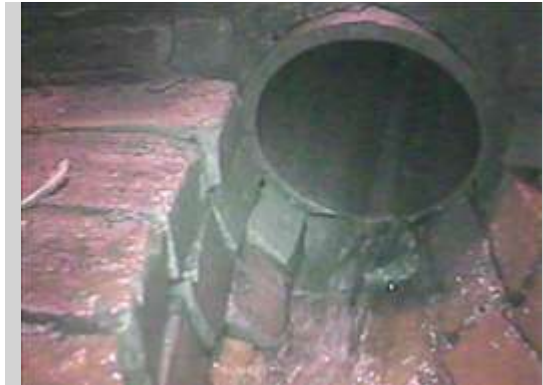
Drop In @ 9 O'Clock

Drop: **Outside Direct**

Inv Depth: **10.50** (ft.)

Drop Condition: **Open**
